Bank Replacement of Our Lakes

When Bank Failure and Soil Loss is Substantial

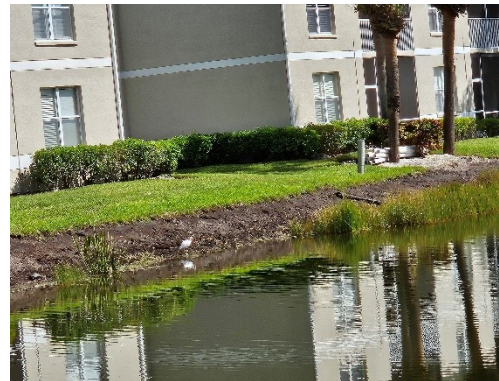
1. Re-establish a bank slope from the current vertical drop which will aid in diminishing wave action during storm events. The bank scraped to produce the necessary slope and consistent bank continuum along the shore it was when initially built.

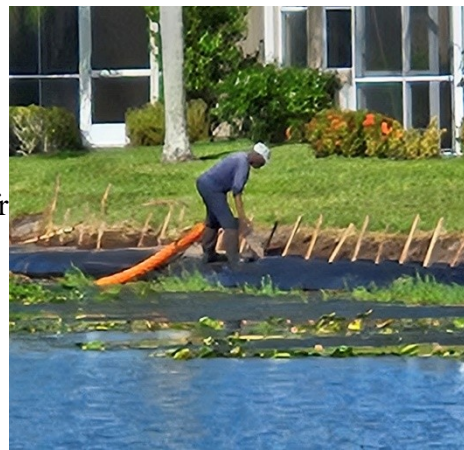
3. The tube is then lined with sediment pumped from an approximately 3-ft diameter tube. Additional layers will be placed on top as needed.

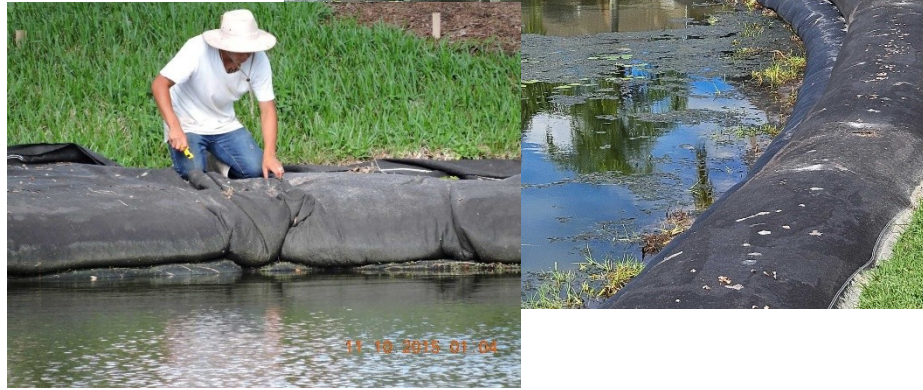
4. A minimum of two layers of tubing are used with the bottom one being more structural and the upper one being 'sacrificial' in that it will be split to expose the sediment in this top layer.

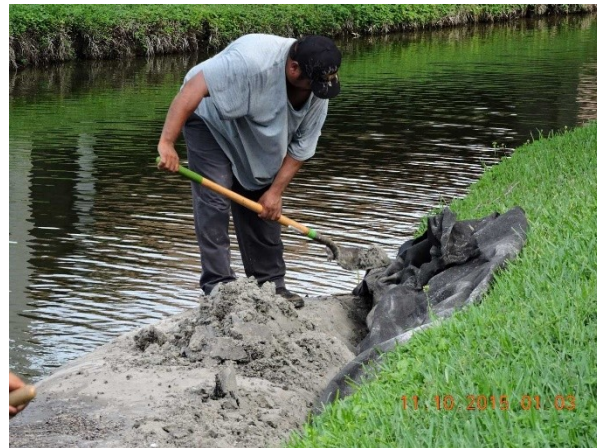
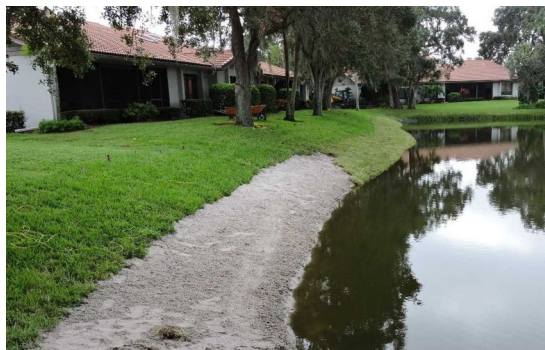
5. The sediment is smoothed out to provide the required slope and final preparation for sod placement.

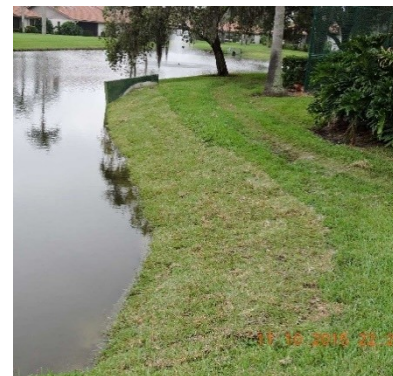
full stabilization of the bank.

6. The sod is placed as the final step and the geotextile tubing is fully covered. Keeping the heavy machinery off of the tubing and recreating the buffer zone is critical for
