## Water Quality Condition Assessment in Lake #5 March 15, 2025

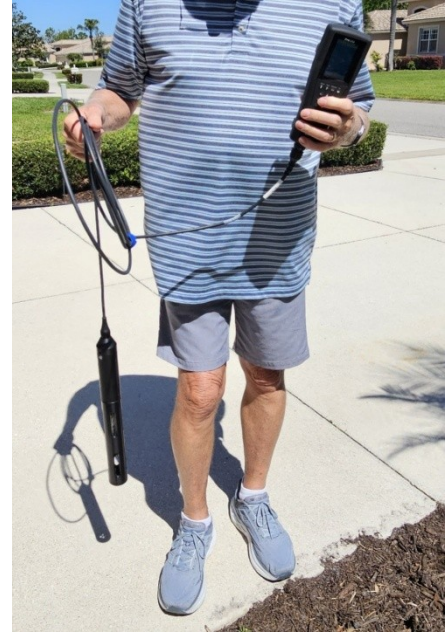
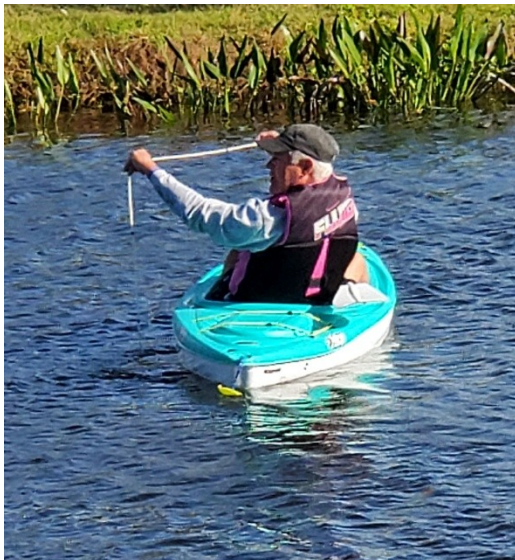
**Summary of Findings:** The lake is shallow throughout with the deepest point noted being 5.6ft, but the majority of the lake less than 3ft. A healthy growth of macrophytes (aquatic plants) suggested good habitat for fish and other aquatic organisms. Of the parameters measured, dissolved oxygen may be the most problematic registering less than 60% saturation in the deeper sections. However, the majority of

locations measured were above 80% saturation which is considered good for aquatic life. Nitrate was lower than the 2.2mg/L level that is an action threshold for our lakes. This is good meaning that the aquatic plants are assimilating the nutrients entering the lake. This is also supported by low chlorophyll readings (meaning low amount of algae in the open water), and the expectation of algae blooms is low.

**Recommendations:** With the overall condition of the lake being in good shape at this time of the season, we recommend that we measure the dissolved oxygen again in the warmer months to determine if the oxygen content is variable enough to prohibit good ecosystem health. A mixing effect would help to facilitate better oxygen throughout, but it is not yet to the point to justify an expensive bubbler unit for this small lake. From a natural perspective it would be helpful to have an alligator in the lake, because one benefit is to provide that mixing effect as the alligator moves throughout the water. Given the healthy plants and habitat, it would be good to put this lake on the list of candidates for fish stocking should we be able to have funds for this project.
